Pre-Renovation Asbestos and Lead Survey Report

**El Camino High School
Drama Classroom Roof**
400 Rancho Del Oro Drive
Oceanside, CA 92057

FACS Project #PJ63100

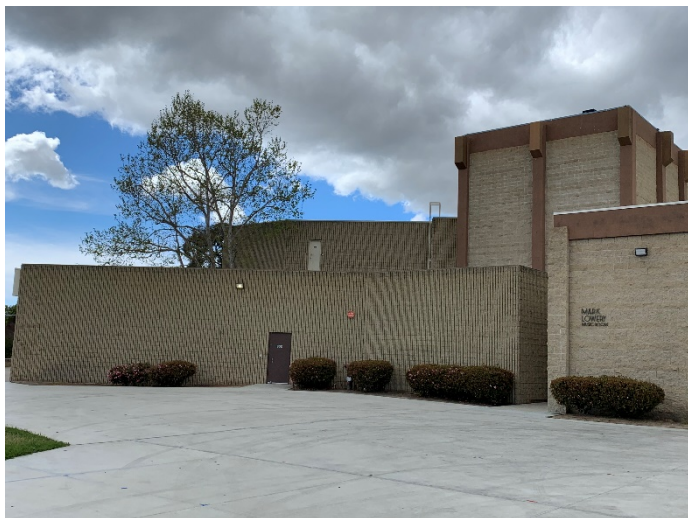
Photo #1: Overview of building, showing drama classroom at forefront

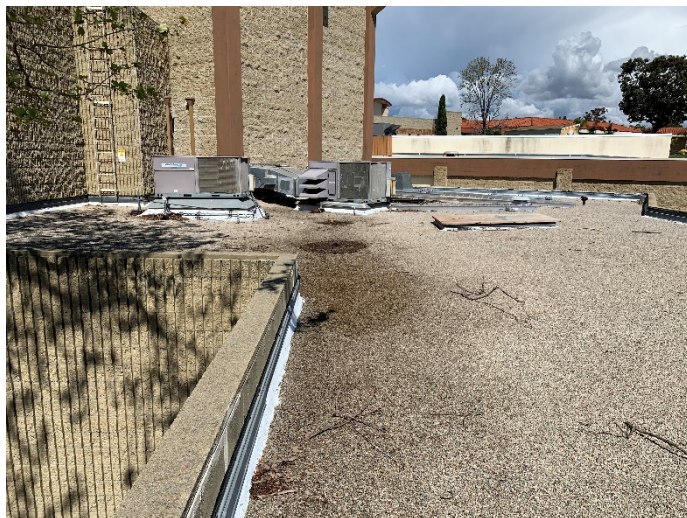
Photo #2: General overview of drama classroom roof

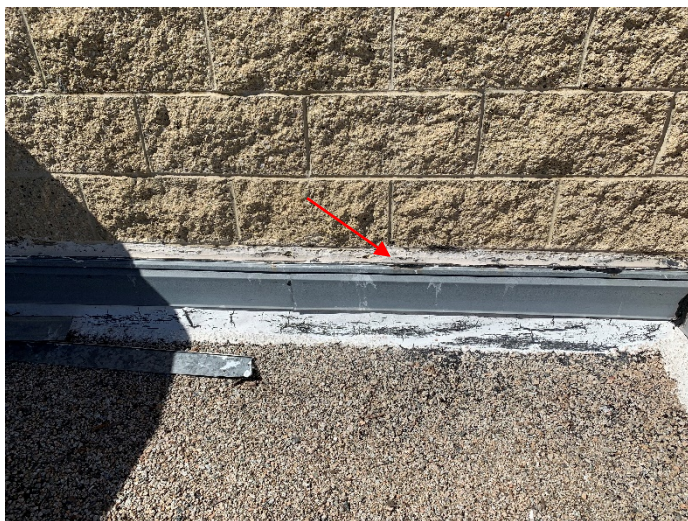
| Sample Number | Material Description | Sample Location | Location(s) of Material | Asbestos Content | Asbestos Regulatory Classification | Approximate Quantity |
|---|---|---|---|---|---|---|
| 02-07 | Flashing Caulk (off-white) | Northeast Column | North and East Parapet Walls | Dark Beige Non-Fibrous Material: ND Black Semi-Fibrous Material: Chrysotile 2 % Beige Non-Fibrous Material: ND | Category 1 non-friable | |

Photo #3: Drama classroom roof, view of lower north wall east of AHU duct, showing asbestos-containing off-white flashing caulk

Personnel impacting the asbestos-containing materials identified during this survey must have asbestos training sufficient to meet Cal/OSHA requirements for a Class II material and use asbestos work practices. Notification for the materials will need to be filed with the appropriate agencies, even if courtesy in nature. To comply with Contractors State License Board (CSLB) requirements, the contractor performing abatement of materials will need to hold a C-22 license or a C-39 roofing license with asbestos certification.

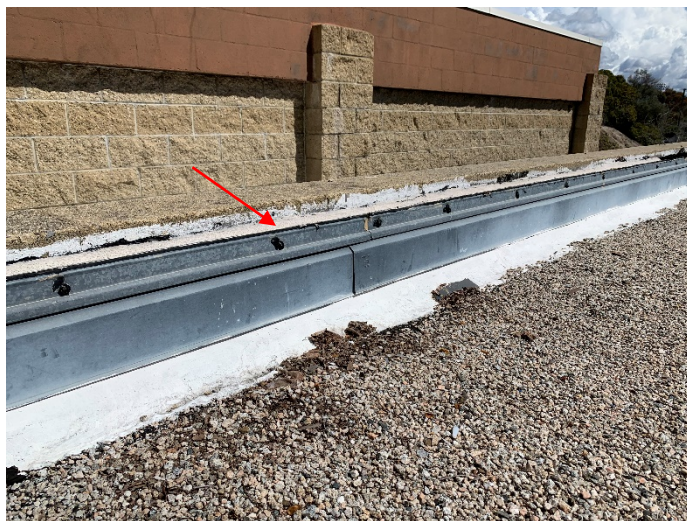
Photo #4: Drama classroom roof, view of east parapet wall, showing asbestos-containing off-white flashing caulk
