April 2, 2021

Pre-Renovation Asbestos and Lead Survey Report

Oceanside High School Gym Roof and HVAC Replacement #875-714 1 Pirates Cove Way Oceanside, CA 92054

FACS Project #PJ63385

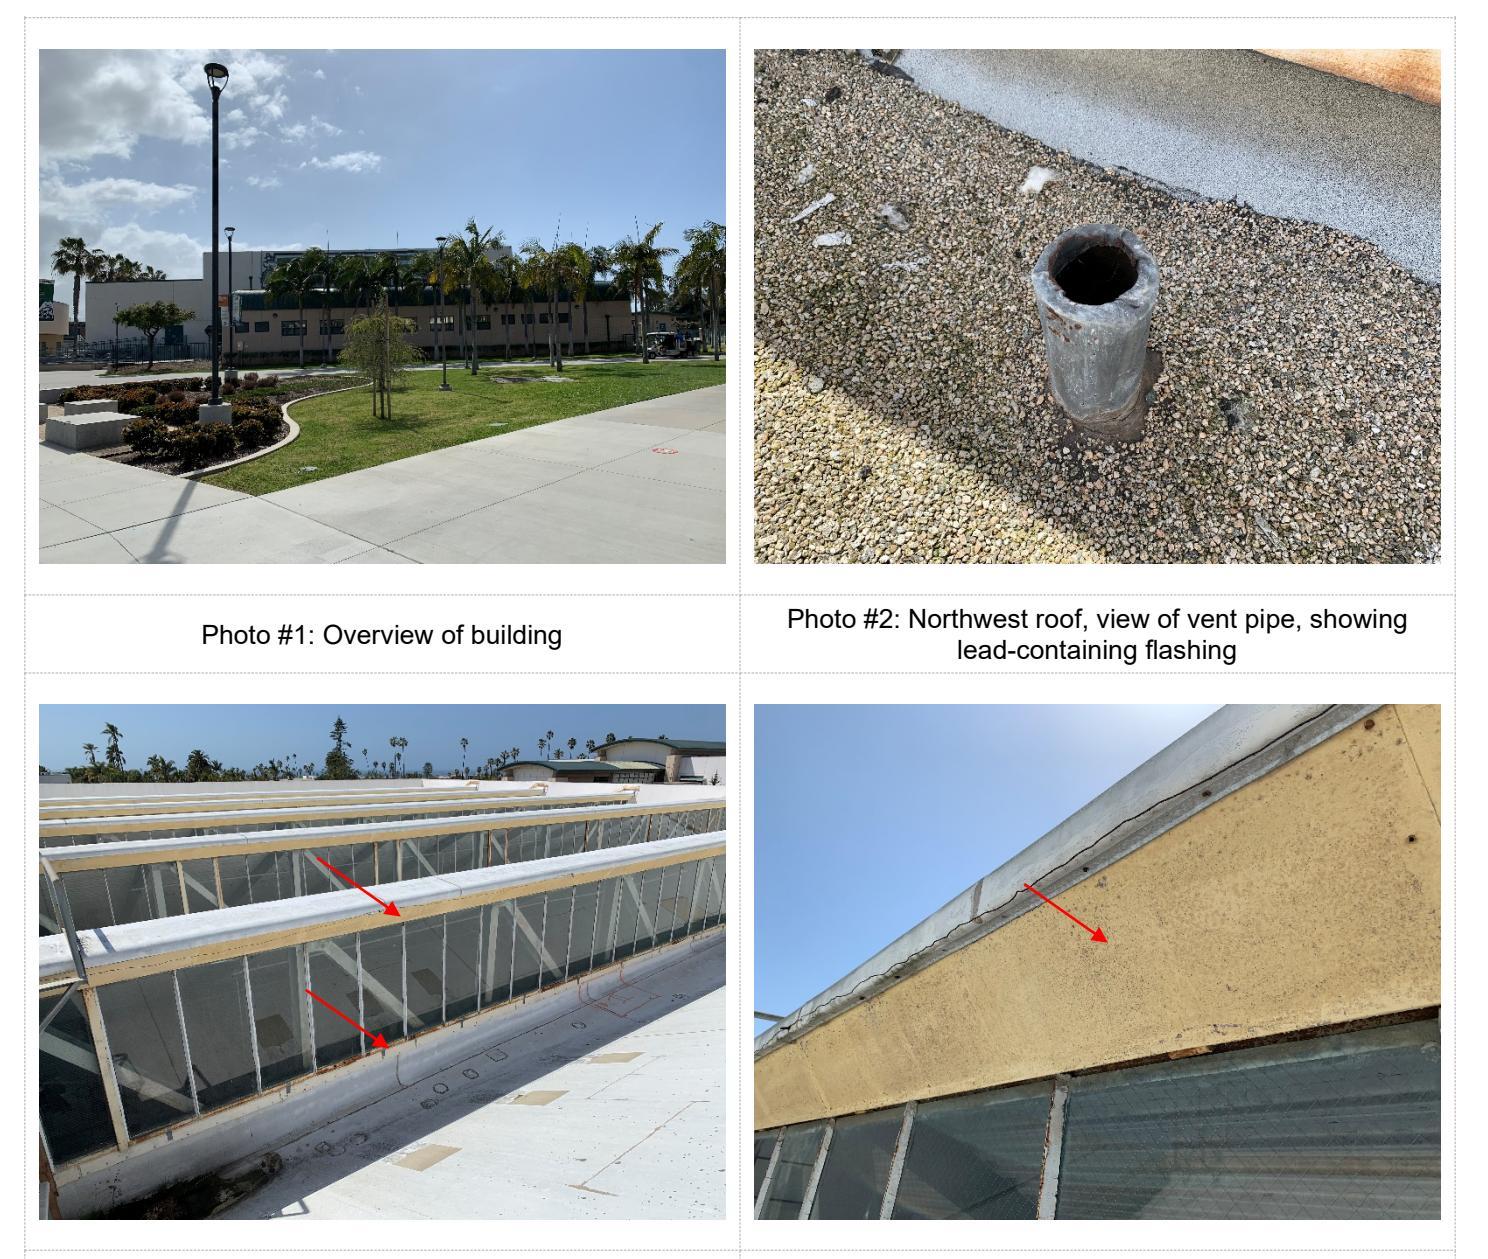
- Metal wrap/flashing surrounding rooftop vent pipes.
- Yellow paint surrounding the windows of the angled roofs.

Photo #3: Center angled roof, showing lead-containing yellow paint surrounding windows

Photo #4: Close-up of photo 3
